# PROFESSIONAL RESERVE STUDY

## The Summit at Autumn Hills

31312 NE 94<sup>th</sup> Circle, Camas, WA 98607

**November 25, 2019**

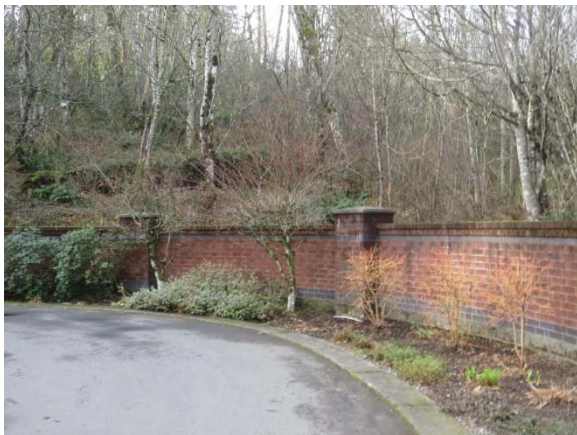
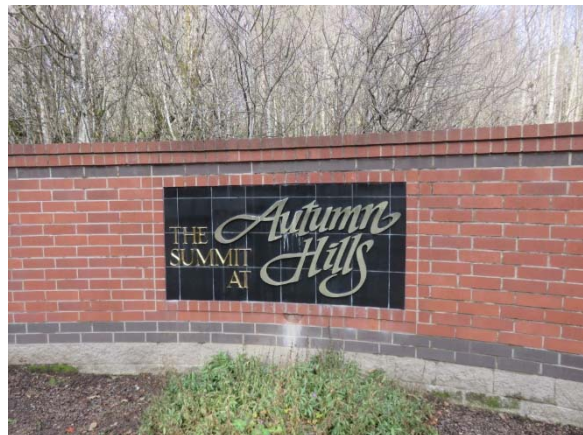
Main Gate Brick Wall and Concrete Cap

We have budgeted for the brick entrance monuments to be cleaned and sealed with a Siloxane water based masonry sealant every 10 years. This will also require minor tuck-pointing in the masonry.

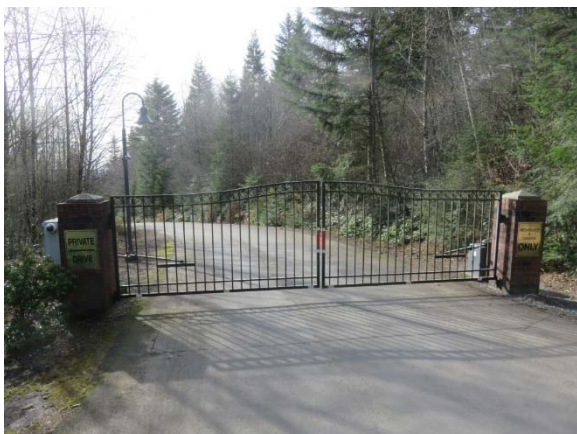
Both Swinging Gates at Gate #3

The gates themselves should have a long lifespan and we have not budgeted for the replacement of the actual gates in the Reserve Study. Any future vehicle damage that occurs to these gates should be paid for by insurance of the driver that causes damage. We do recommend that the metal gates be electrostatically coated every 5 years to minimize corrosion

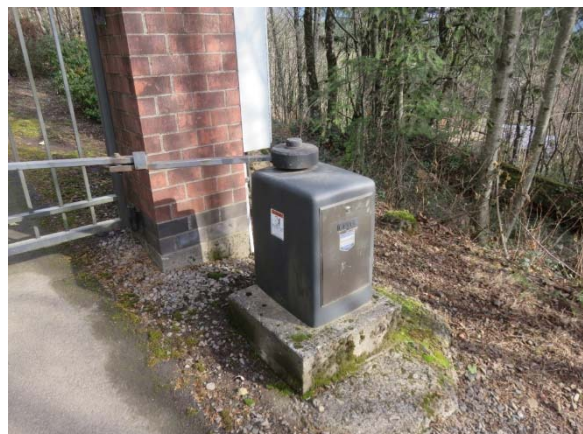
One of Two Gate Operators at Gate #3

There are a total of two control panels and 5 Elite gate operators. We have budgeted for the control panels to be replaced on a 15 year cycle going forward. Additionally, we have budgeted for the gate operators to be replaced on a 12-year life cycle.

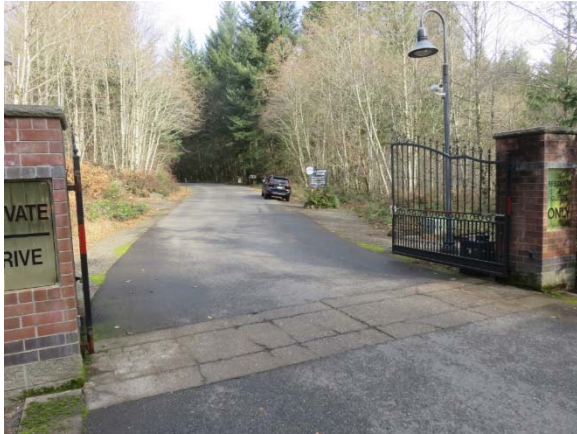
Gate #1 (The Main Entrance Gate) consists of a brick wall and brick pillars and two swinging metal gates that are operated by two Elite gate operators. We understand that the gate was recently replaced do to vehicle damage. We understand that the gate control panel was largely replaced with all new components in 2014.

Both Swinging Gates at Main Gate

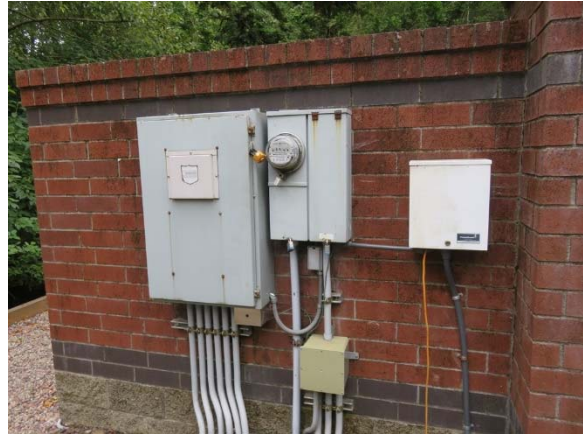
Electrical Breaker Panel and Meter at Gate #1

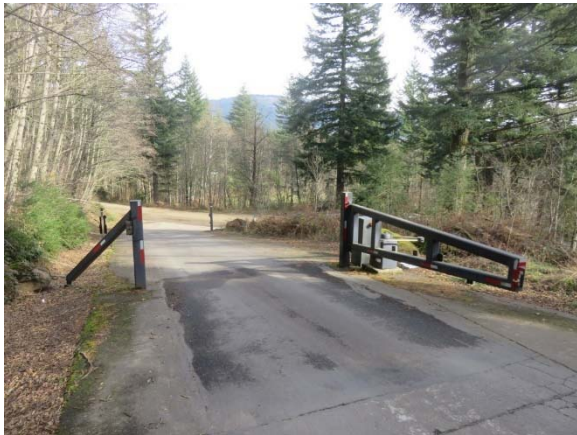
Gate #2

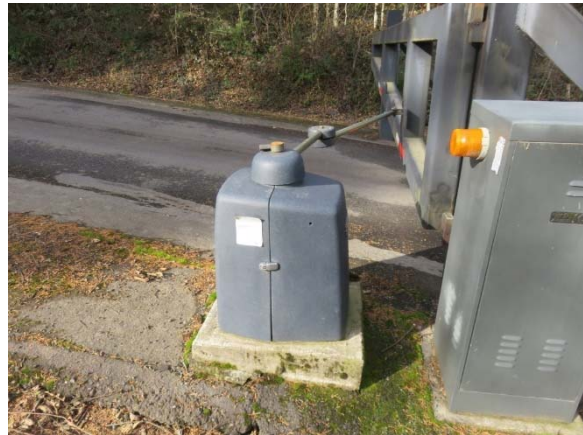
Gate #2 Operator

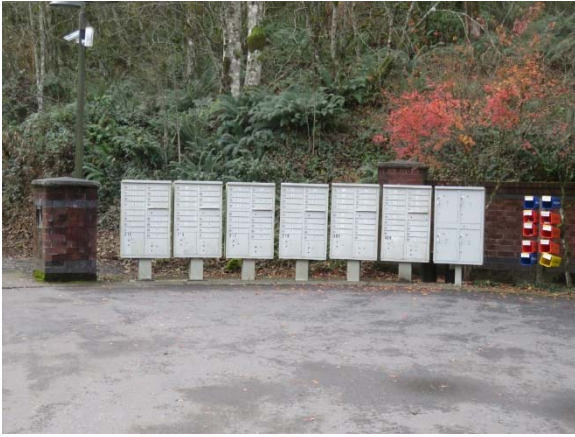
There are six metal mailbox kiosks at the main entrance to this neighborhood. These metal mailbox kiosks are generally in good condition. These metal mailbox kiosks have a typical lifespan of 25 years.

Mailboxes

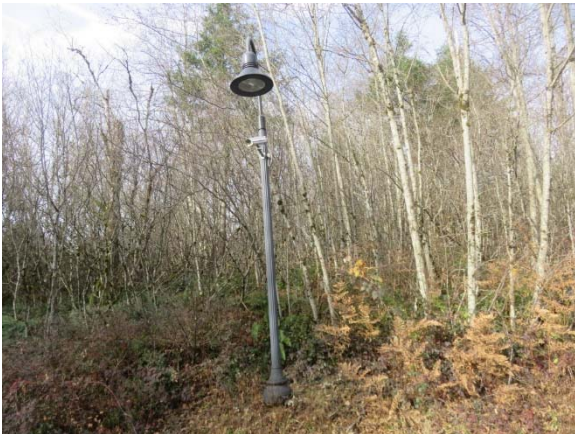
There are 3 pole mounted lights near gate #1 at the main entrance to this neighborhood, one light at gate #2, and two lights at gate #3. These lights are the responsibility of the homeowners association to maintain. We have estimated that these lights will have a lifespan of 40 years.

One of Six Pole Mounted Lights

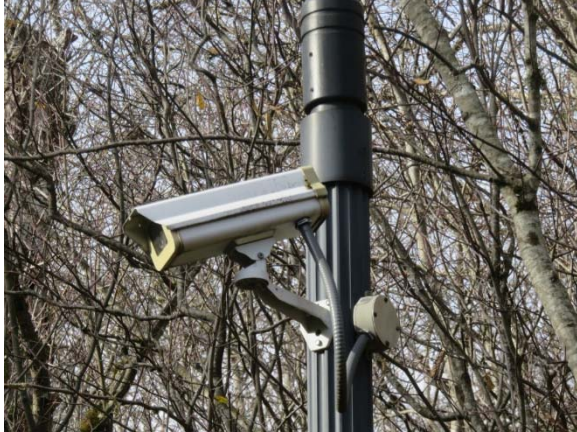
There is a surveillance system at gate #1 and at gate #3. We understand that this system is antiquated and there is a desire to upgrade this system within the near future to a more usable system with clearer images. We have budgeted for a periodic surveillance system upgrade allotment of \$10,000 every 5 years starting in 2020.

Surveillance Camera at Main Gate

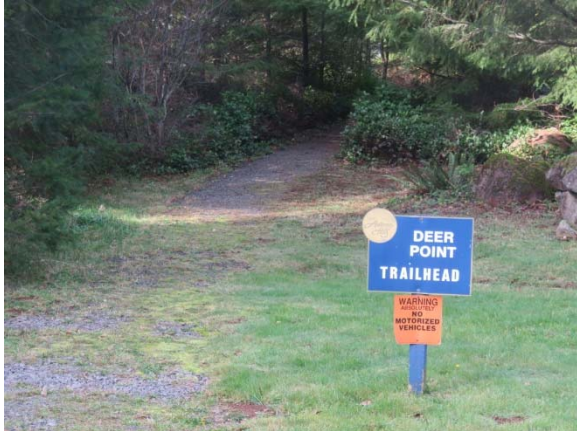
There are numerous road signs and trail signs located throughout this development that include stop signs, speed limit signs, and trail marker signs. Generally the street signs are in good condition. We have not budgeted for any sign maintenance or replacement in this study, as we have assumed that sign replacement will be paid for via the operating budget.

Trail Sign

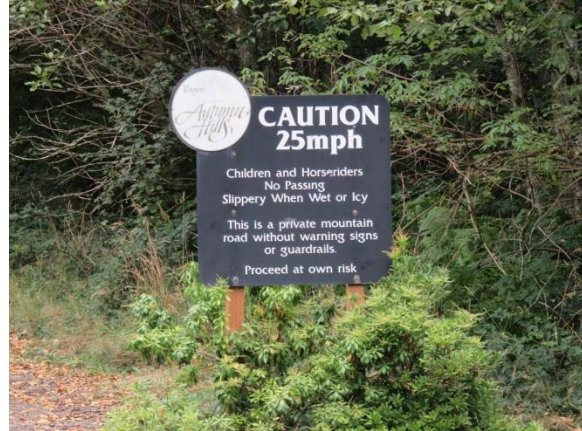
Road Sign

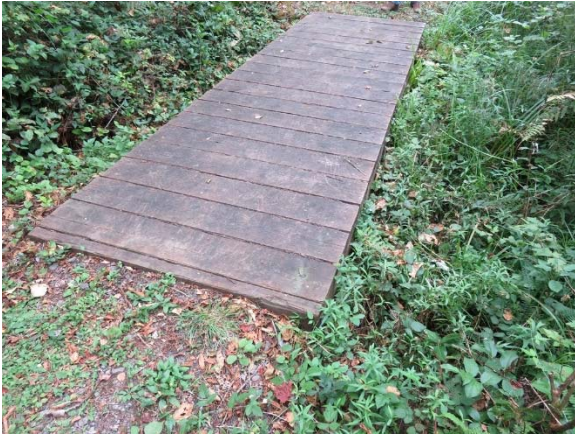
There are 3 trail bridges that are part of the trail system. We understand that these trail bridges were constructed around 2008. We have assumed that these trail bridges will have a total lifespan of 15 years.

One of Three Trail Bridges

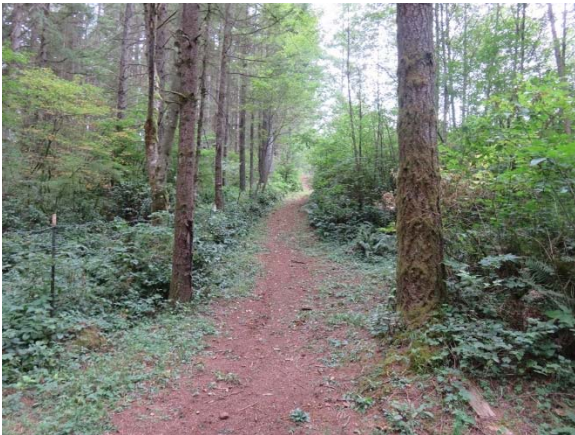
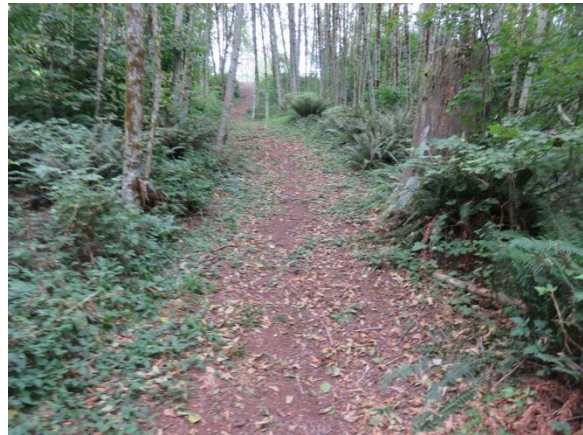
There is a trail system in this development that we understand consists of almost 4 miles of trails. Beyond the ultimate replacement of the 3 trail bridges, the trail system is maintained entirely via the general operating budget. Therefore, no funding has been budgeted for this trail system in the Reserve Study outside of the 3 bridges.

Typical Trail

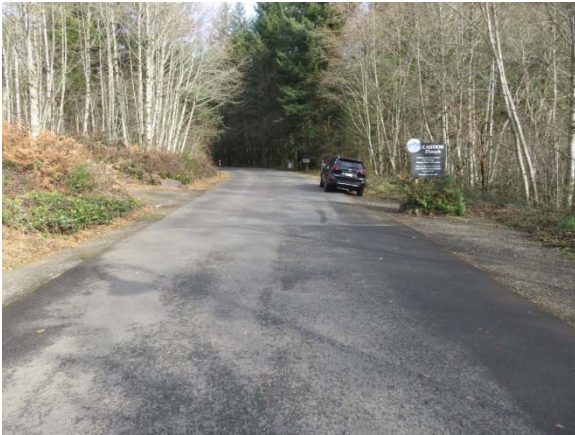
Road Just Inside Main Gate

There are approximately 5 miles of roads for an approximate total of 580,800 square feet of asphalt on this property. We have budgeted for overlaying the roads with a 2-inch asphalt overlay in sections, with asphalt life cycles that correspond to the amount of use. We have divided the overlay projects into 6 phases in order to spread the cost of asphalt overlays across several years to help miter the financial burden on the Association as a whole. The intervals that we believe are most appropriate are the following:

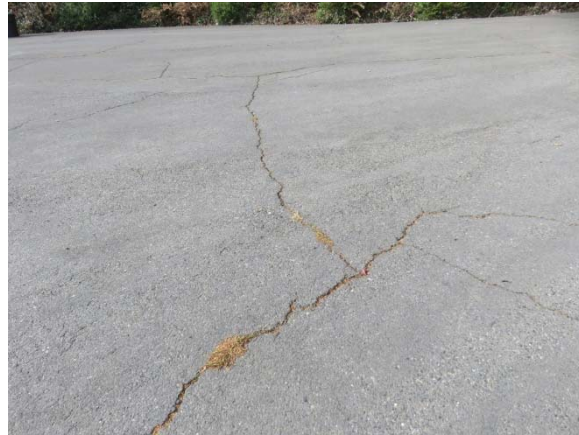
Typical Asphalt Cracking

The roads committed has been very aggressive in recent years replacing extensive areas of their roads; however, this Association is of an age that there are many more areas to replace and have rubber crack sealing. Therefore, in order to stay in step with reality at this property, we have budgeted for an annual asphalt patching allotment that is much higher than we have budgeted for in the past.

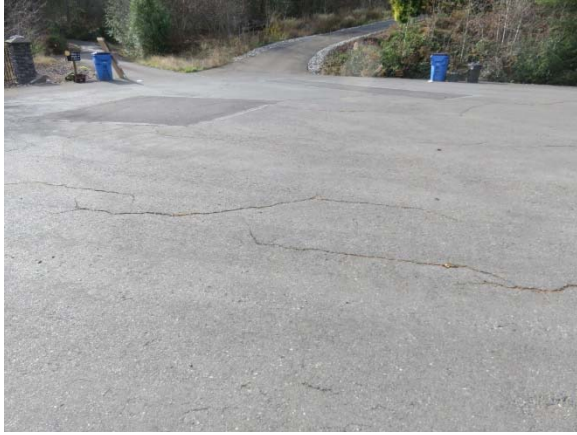
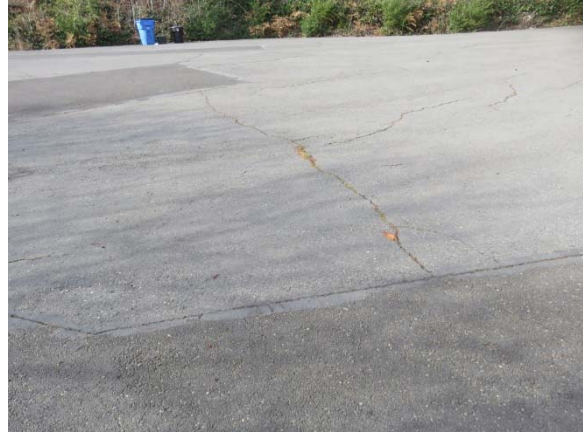
Typical Area of Asphalt Damage in Need of Repair

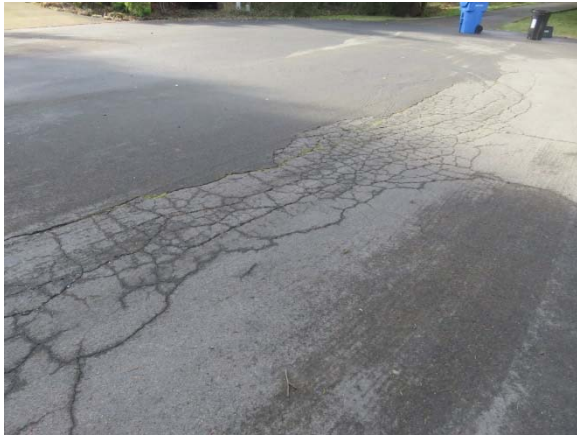
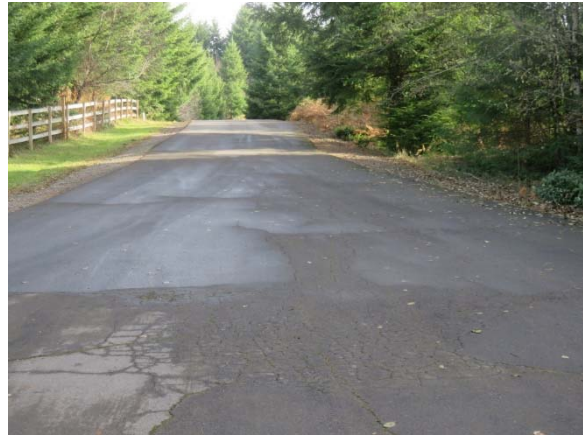
Typical Area of Asphalt Damage

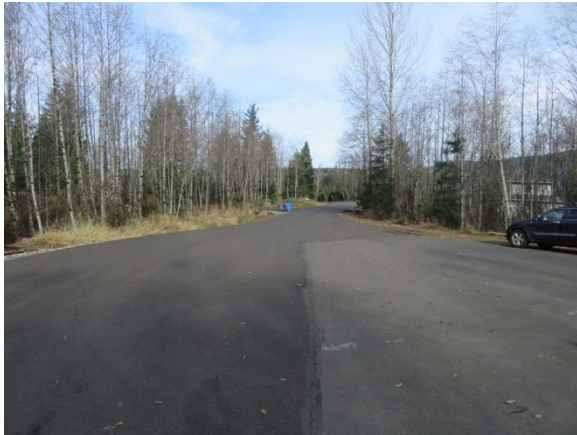
Newly Patched Area of Asphalt

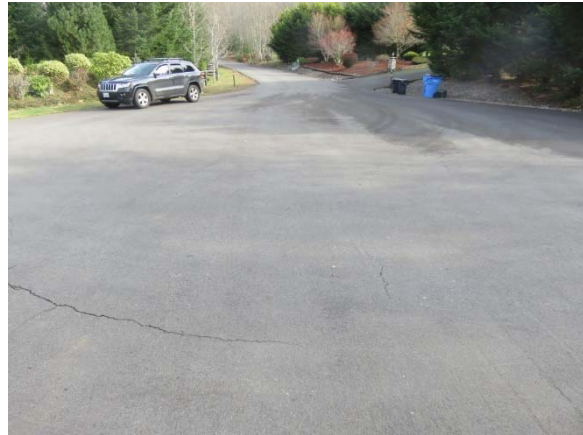
Cul-de-sac in Relatively Good Condition

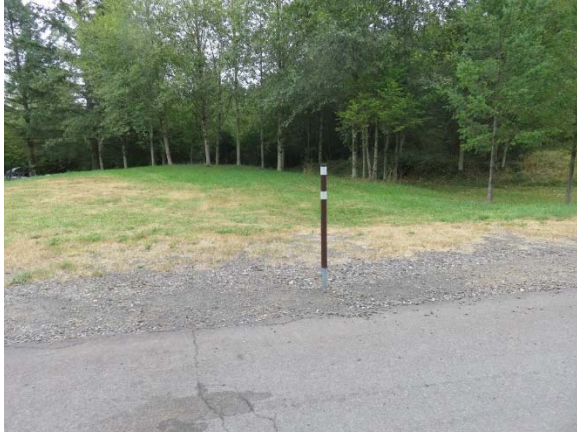
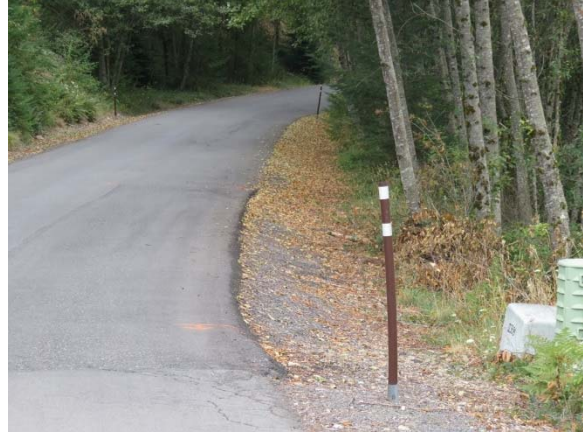
There are road marker poles located throughout the development. We understand that these road markers are in place to help drivers stay on the road during times of heavy fog. We understand from the roads committee that these road markers are replaced as necessary via the general operating budget as they are relatively inexpensive.

Typical Road Marker

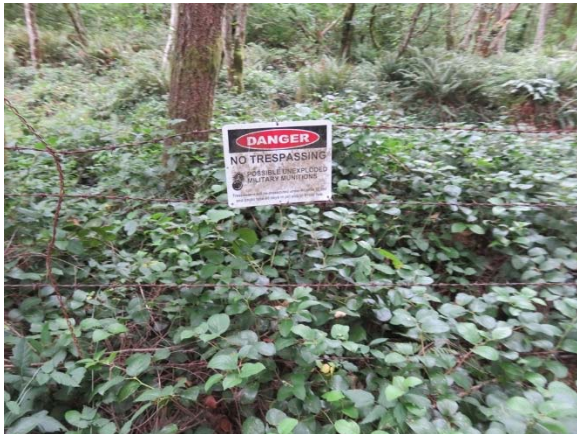
There is chain link fencing along the perimeter of this development that is owned entirely by the neighboring property. Therefore, no funding has been allotted to replace this chain link fencing.

East Chain Link Fence Owned by Neighboring Property
